Comox Valley Nature Wetland Restoration Project Report 2012

Prepared by Frank Hovenden

Comox Valley Naturalists Society

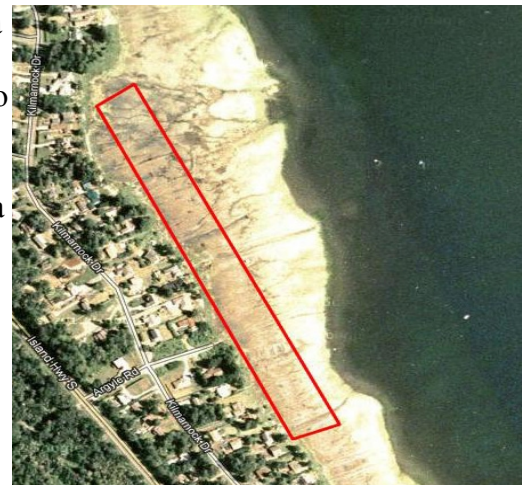
Figure 2: Area 8 Argyle Rd.

A new area was added to our core areas of concern this year. Area eight contains a number of purple loosestrife plants and yellow flag iris which were discovered 3 years ago. It is situated slightly to the south of our historic core areas along the shore of Baynes Sound in the Argyle Road area of the CVRD. It was felt by Sellentin's Habitat Restoration that these plants were contributing a large amount of seed which was being deposited in the Courtenay River estuary due to southeast storm events. The purple loosestrife plants here are growing along the shoreline in fresh water seepages.

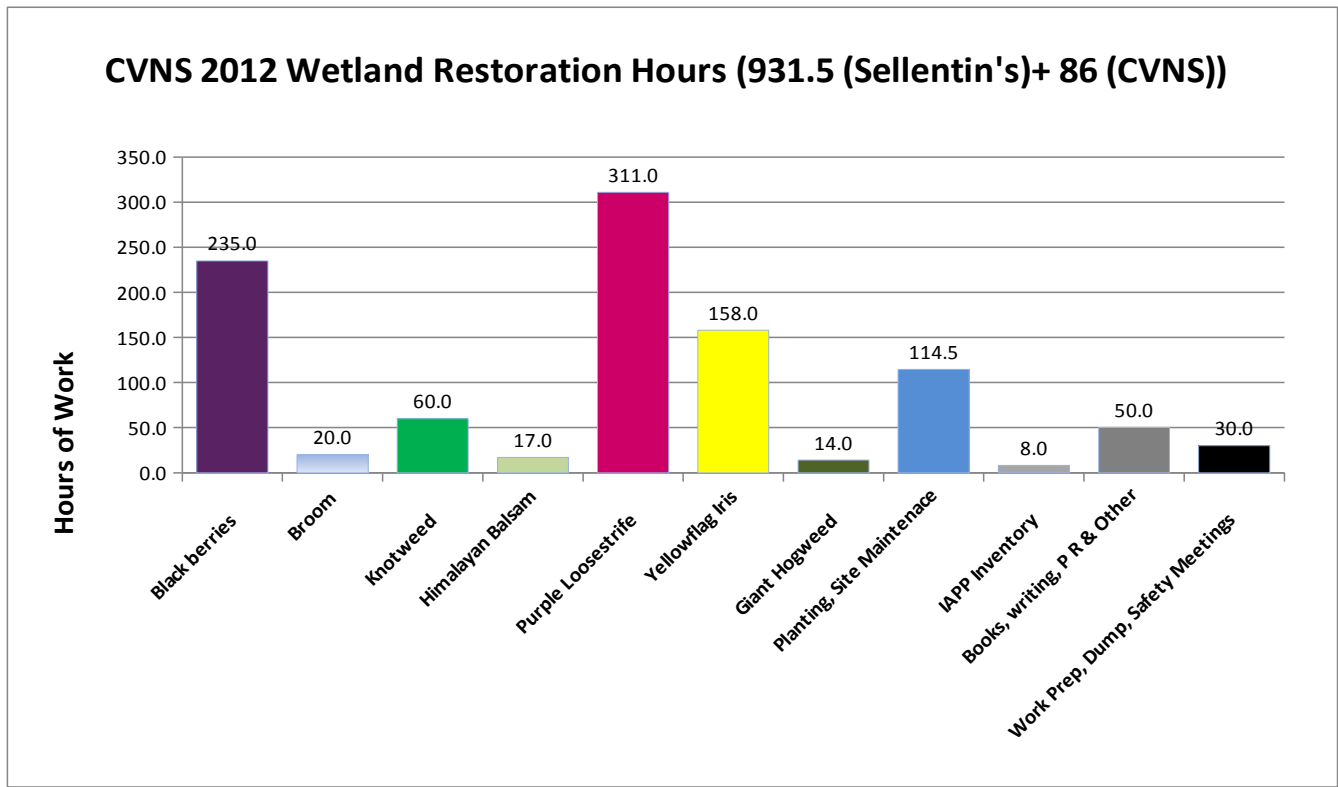
Figure 4: Project hours by task

The project hours were tracked by task and geographic area. This year Sellentin's Habitat Restoration completed a total of 931.5 hours of field work for the project. This was augmented by 86 hours of volunteer labour from the CVNS. The volunteer work consisted of removing Scotch broom from the Courtenay River Airpark and the cutting of knotweed along the Courtenay River. In addition the volunteers maintained the signage in the Courtenay River Airpark, performed public outreach and assisted with the prescribed burn.

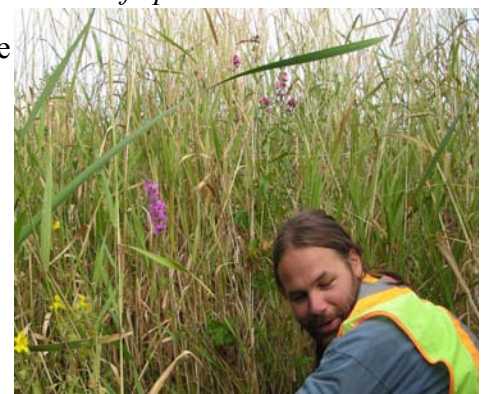
Figure 5: Brian Hay removing a purple loosestrife plant

The number of purple loosestrife plants removed this year was 3566 which is an increase from the 2328 plants found the previous year. The numbers although less than a tenth of what they were in 1999 have nonetheless shown a slight increase in the last 3 years. The vast majority of these plants continue to come from Area 6.

Because of the plant's ability to reproduce from small bits of root, all purple loosestrife was disposed of at the Comox Valley Waste Management Centre. This year a total of 510 kg. of purple loosestrife was disposed of in this fashion.

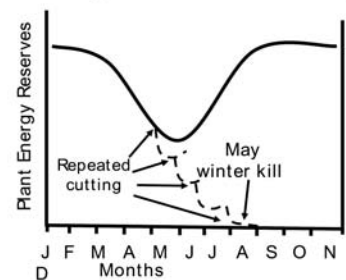
Figure 8: Multiple cuts reduce energy reserves

As the adjacent graph shows the plant is attacked when its energy reserves are at their lowest. This starts with the new growth in the spring. Repeated cutting continues to deplete the plants' energy reserves.

Attack the plant at its weakest point

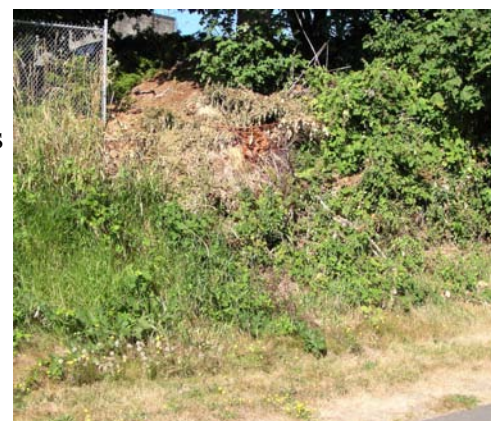
Figure 11: Illegal dumping behind the Dairy Queen

Even more troubling is the continuing illegal dumping of landscape refuse on public property. The photo in Figure 11 shows one site behind the local Dairy Queen. A break in the fence has allowed a landscaper to dump his refuse along the Courtenay River walkway. There are at least 6 different invasive plants including knotweed at this location. A 'No Dumping' sign and better fencing might be a start to addressing this problem.

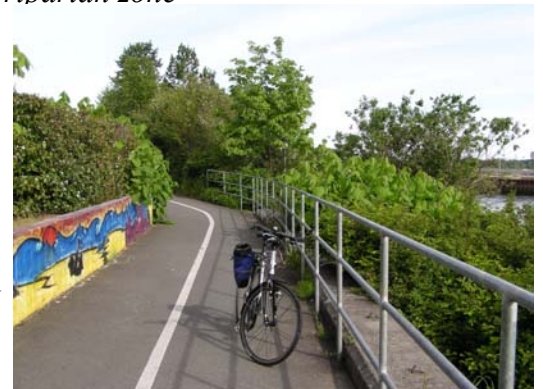
Figure 12: Knotweed extending from private land under the walkway and into riparian zone

The 20th Street (Figure 12) site shows some of the problems in controlling an invasive like knotweed in the urban environment. On this site the plant is growing on both sides of the Courtenay River Walkway. On the lower side it is established in the riparian zone of the Courtenay River. Control cutting was done here, with limited effect.

This is due to the root system of the plant which extend under the walkway and into the private land on the upper side. It is clear that for continuous cutting to be effective there can be no outlying connected patches left.

Knotweed roots travel great distances underground and the emerging plant is extremely powerful. Figure 12 shows the plant from the 19th Street site growing on both sides of the walkway. Despite the nine cuttings, control at this site is poor. We feel this can be attributed to the satellite patch on private property on the high side of the River Walkway.

Knotweed is not only a threat to the natural environment but is also damaging to infrastructure. The plant is capable of penetrating paved surfaces and even house foundations. In Illustration 12 young plants can be seen emerging through the pavement next to the retaining wall.

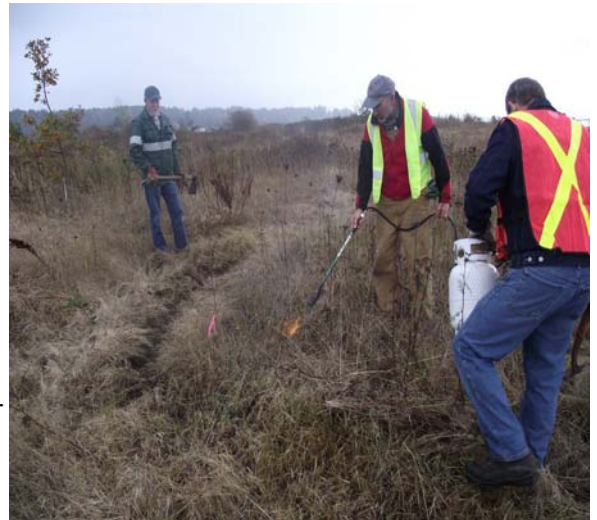
Figure 13: Attempted burn at Courtenay River Airpark

The summer drought did not allow a safe burn until mid October. Photos were taken of the plots as well as existing plants noted. A fire permit was obtained from the Courtenay Fire Department, and a crew organized when a small window of opportunity presented itself. Unfortunately a rain shower arrived shortly before we had planned to light up. This dampened the fine fuels sufficiently so that ignition was impossible. It is our hope to attempt this experiment early in the new year.

As can be seen in Figure 13 vegetation surrounding the plot was cut and a small fire guard dug. As part of the permit requirements a water pump and hose were on site. Due to the small size of the plots and their location surrounded by the lagoon we are confident that these burns can be done quickly and safely with minimum disturbance to the public.

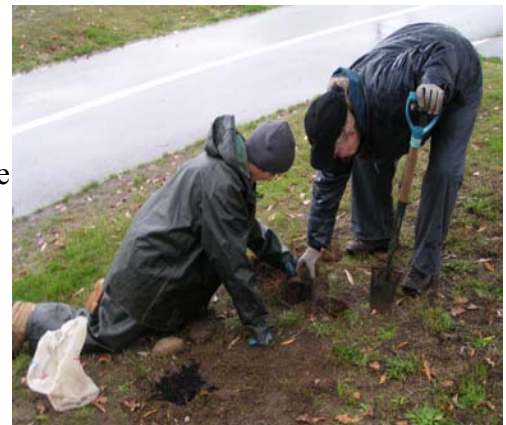
Figure 14: Youth for Ecological Restoration planting camas bulbs

The plants added this year are listed in Appendix I. The spring plantings were purchased from Steamside Native Plants in Bowser BC. Camas seed was collected in the estuary from the previous year and spread around many of the Garry oaks. Close to 100 camas bulbs were donated to the project from a plant rescue by Louise Goulet. These were planted in October with the assistance of the Youth for Ecological Restoration.

Large organic debris (LOD) is scattered around all new plantings. The new plantings are mulched with a soil ameliorant and a sprinkling of bone meal in the planting hole. Maintenance during the summer drought period consists of weekly watering of the plants installed during the current year. Also the areas around the plants are weeded once during the first year.
